ASTM F1233-08 PERFORMANCE TEST REPORT

HAMMERGLASS AB

Two Configurations of Polycarbonate Specimens

Report No.: G6655.01-119-12

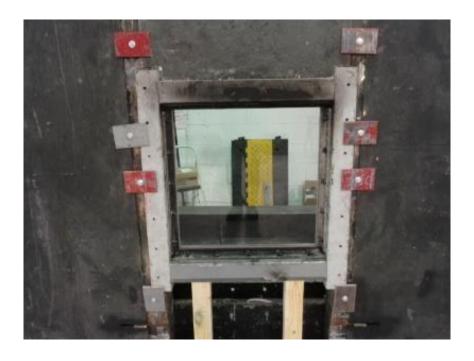
Photo No. 1 Specimen No. 1 - Test Setup

Installation: The test fixture was constructed in accordance with ASTM F1233. The polycarbonate panels were placed into the fixture against 1/8" thick foam glazing tape and secured with steel angle with 1/8" thick foam glazing tape against the panels. The steel angle was secured to the test frame with five (5) 1/2" diameter bolts on all four sides.

Forced Entry Resistance Test Set-up: The specimen was rigidly mounted for forced entry resistance testing. The resources (tools) for forced entry testing were provided to test personnel, in addition to a 1/8" diameter rod (Contraband) and an 8" x 8" x 5" solid rectangular object (Body Passage). A tripod-mounted video camera was used to record the entire forced entry test sequence. Concentrated assault team members are listed in the following table.

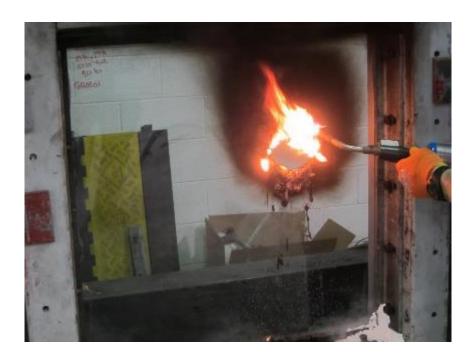
Photo No. 2 Specimen No. 1 - Contraband Failure

¹ After 01:30 seconds during Sequence 6, the 1/8" diameter rod was able to pass freely through the specimen.

Description of Attack: Forced entry personnel were directed to attack the sample of laminated glazing secured in the FER fixture. Testing began with Sequence 1 and continued until the propane torch was utilized to create an opening through the sample allowing free passage of the contraband after 01:33 min during Sequence No. 6. The testing was continued until bodily passage failure occurred during Sequence No. 6 after five minutes of the propane torch. The surface temperature of the test specimen was recorded following each attack sequence.

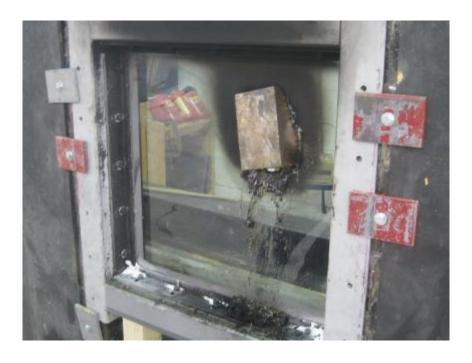
Photo No. 3 Specimen No. 1 - Body Passage Failure

² After the 05:00 minutes during Sequence 6, the 8" x 8" x 5" solid rectangular object was able to pass freely through the specimen. No further testing was performed.

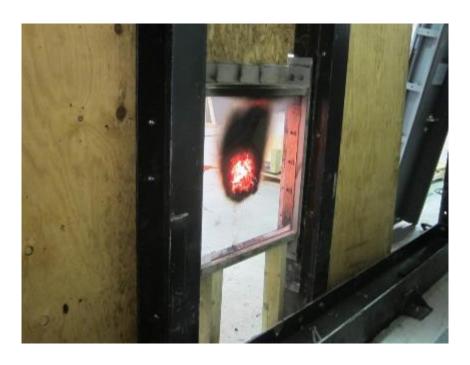
Photo No. 5 Specimen No. 2 - Contraband Failure

¹ After 05:00 min during Sequence 6, the 1/8" diameter rod was able to pass freely through the specimen.

Description of Attack: Forced entry personnel were directed to attack the sample of laminated glazing secured in the FER fixture. Testing began with Sequence 1 and continued until the propane torch was utilized to create an opening through the sample allowing free passage of the contraband after 05:00 min during Sequence No. 6. The testing was continued until bodily passage failure occurred during Sequence No. 10 after five impacts. The surface temperature of the test specimen was recorded following each attack sequence.

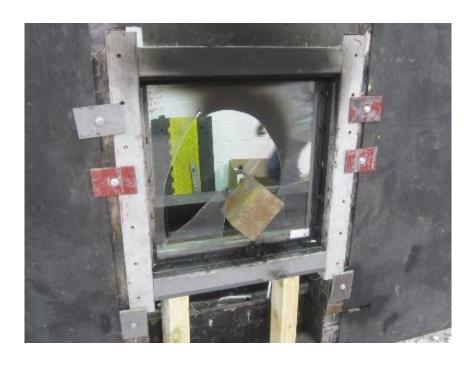
Photo No. 6 Specimen No. 2 - Body Passage Failure

² After five impacts during Sequence 10, the $8" \times 8" \times 5"$ solid rectangular object was able to pass freely through the specimen. No further testing was performed.
